Re: Papa Johns ADA Compliance Evaluation

As requested, I visited the above-referenced property to conduct visual observations in order to provide this ADA compliance evaluation of the KAIS ABID, d/b/a PAPA JOHN'S, KAM FOUR, INC, d/b/a PAPA JOHN'S, PARKER EAST 24th APARTMENTS, LLC and PARKER COMMERCIAL 24th ASSOCIATES and 305 EAST 24TH OWNERS CORP located at 432 Second Ave. New York, New York.

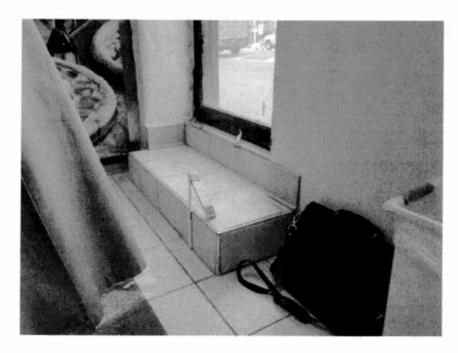
In order to enter the space through the entrance along the sidewalk of 2 Av., a person must descend two (2) steps of unequal riser height (6" and 7") and unequal tread depth.

Picture 1: Store entrance, 6" and 7" stairs on entrance.

- 1. Entrance steps and doorway: To address this condition, a permanent small ramp can be constructed from the sidewalk level up to the main floor level; the ramp would require appropriate slope, railings, and signage as required by 28 C.F.R. 36 to provide an accessible and properly designated entrance. In the alternative, a wheelchair lift may be used. In the alternative, an ADA compliant portable ramp with a non-slip surface may be used in conjunction with ADA accessible signage and buzzer to comply with 28 C.F.R. Part § 36.304 (e). A cost estimate of providing an ADA compliant wheelchair lift is approximately \$10,000.

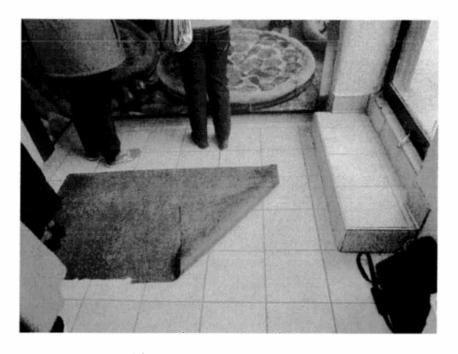
Picture 2: Unsecured entry mat

- 5. Secured Mats: The existing non ADA compliant mats in the store layout can be secured to be in compliance with 28 C.F.R. Part 36 and 2010 Standard, Section 302.2.

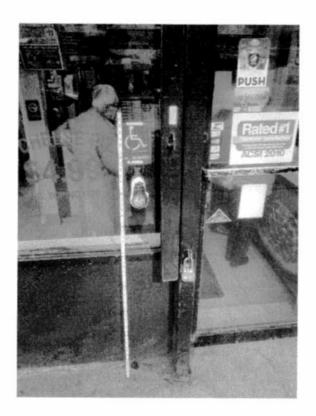
Picture 3: Inaccessible ADA signage and buzzer

- 4. *Signage:* Appropriate visual and/or tactile signage regarding services available should be provided to comply with 28 C.F.R. Part 36, Section 4.1.3(16) and 28 C.F.R. Part 36, Section 4.30.4. A cost estimate of providing appropriate signage is approximately \$200.
